Stalled MGA Restoration Cautionary Tale

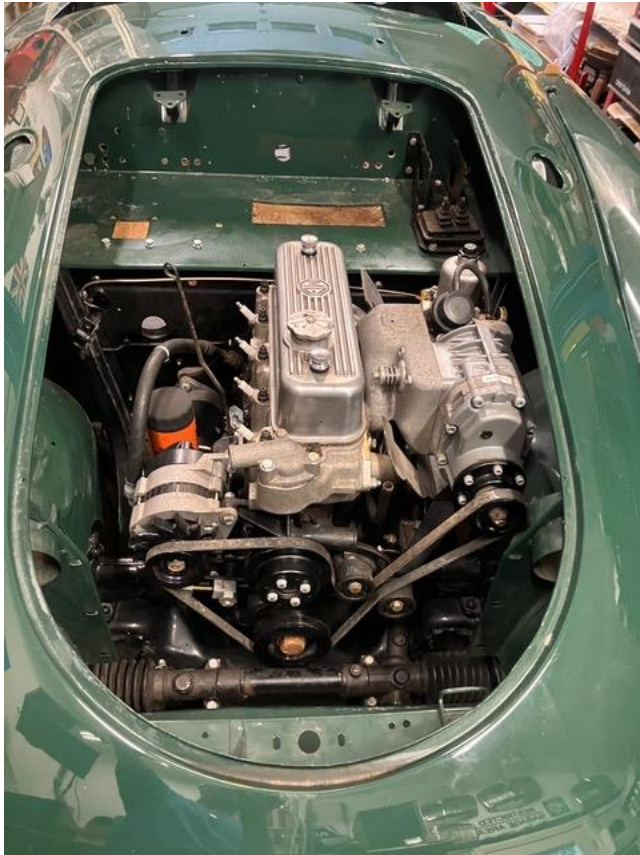
In the beginning

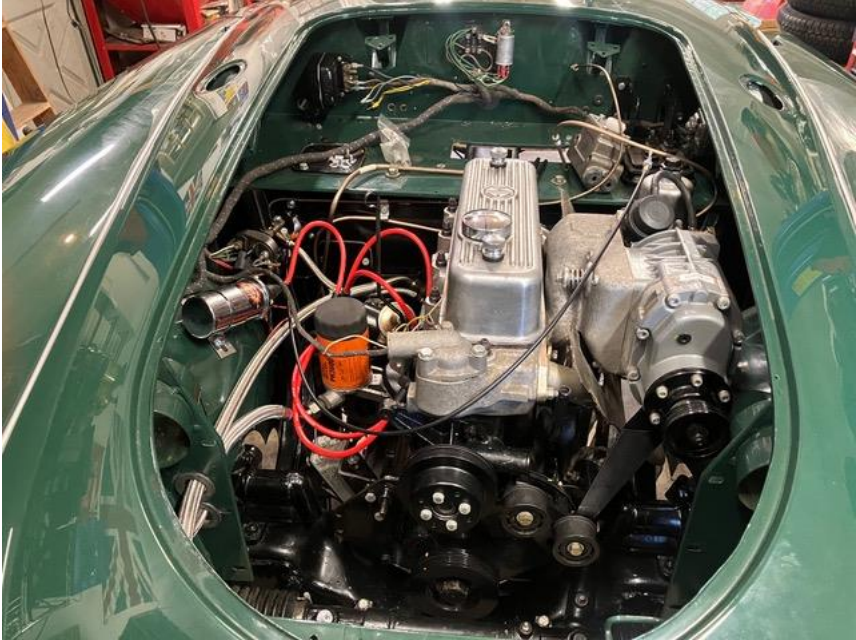
After working on it for many hours
