Stalled Restoration Project Update: The Rest of the Story

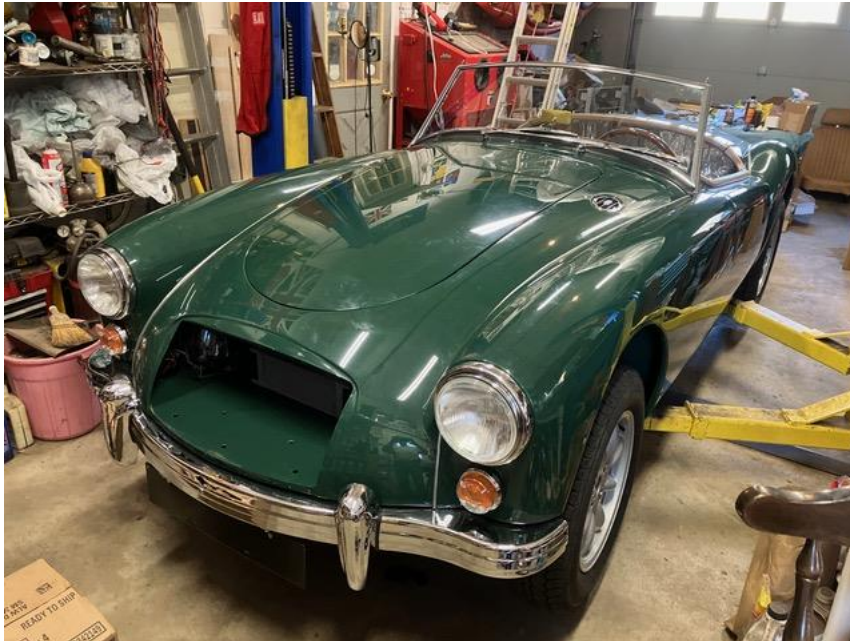
Making progress

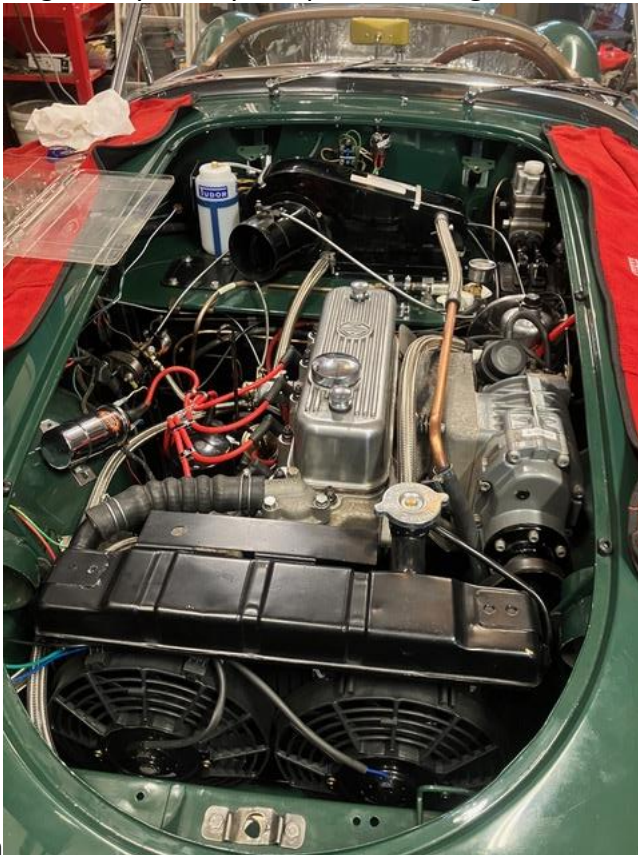
Engine bay mostly complete and engine runs and hydraulics work!
