Results of BSMGAC Spring Tech Session

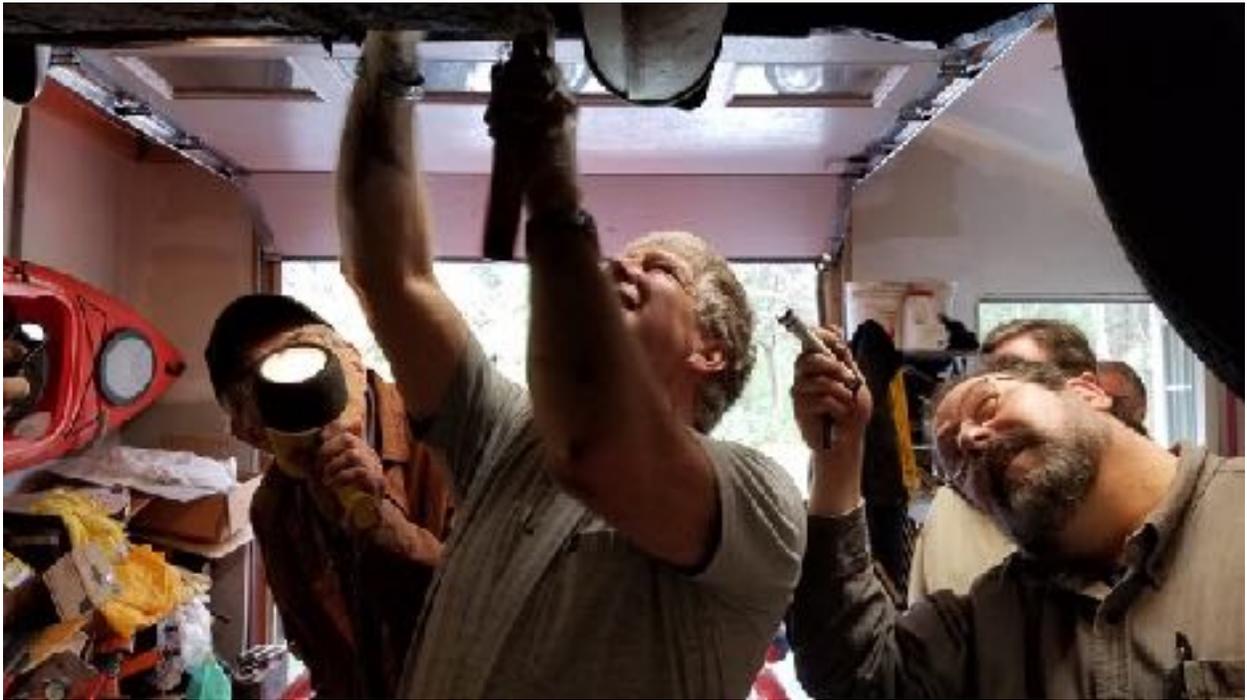
Replacing a fuel tank begins with removing the rear bolts, with Bruce and Ira looking on.

May 6, 2018 did not cooperate with the weather, but we still had a great turn out and had 3 MGAs present. John Gill came first with his MGA to help me set up. We got everything organized and members and guests started arriving around 10 am. We often do a few oil changes and other small technical jobs on various cars, but this time we had the major work of replacing a fuel tank on Ira Cohen's MGA. His tank had been leaking when full and he had purchased a replacement about 10 years ago but had never put it in. I had been pestering him for a number of years to do the job. Well, we started out by putting the car on the lift and raising it enough to drain the tank. The next thing was to remove the fuel filler neck and hose with trunk floor sealing gasket and bracket. We put the lift the rest of the way up and removed the right rear wheel to gain better access to the sending unit and fuel output connection. Then the process started with lubricating all the nuts and bolts and cleaning away road grime and undercoating from the connections. The fuel outlet took a 3/4" open end wrench and the fuel sending unit wire took a 7/32" socket (this is a Whitworth sized nut, but the SAE socket fits). We wanted to remove the tank with the straps still attached as we needed to clean and inspect them and it is easier to refit them on the new tank with the tank off the car. We removed the two 1/2" head bolts from the front of the tank while supporting the tank with a transmission jack and then the two 7/16" head bolts that allow the tank to pivot at the rear. The tank has to be pivoted down at the front and then the filler neck withdrawn toward the front and down to clear the tank from the car.

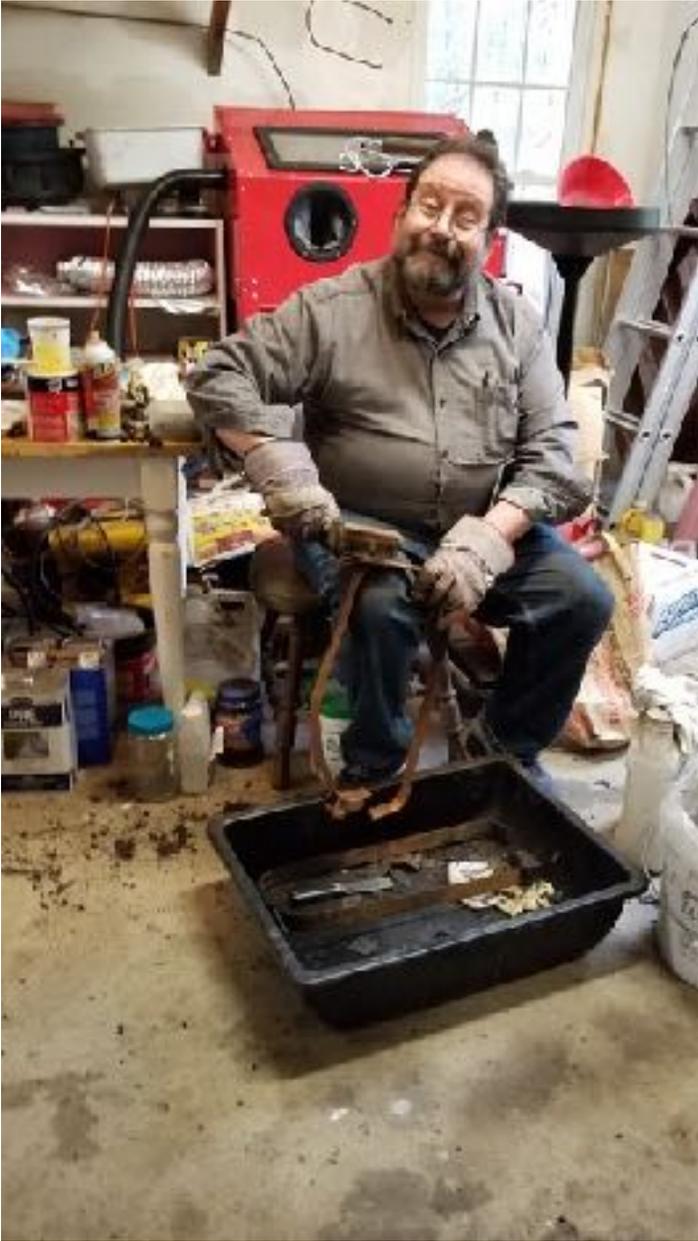
Ira cleans the tank straps.

We removed the straps from the tank and Ira cleaned these and determined that one was badly deteriorated, so, I found a spare and we cleaned that one up. We sprayed some rust converting chassis paint from Eastwood on the straps and put the new rubbers between the straps and the new tank. I demonstrated how to determine if the sending unit is working correctly by measuring the resistance with a ohm meter with the float down (empty - about 20 ohms) and up (full - about 130 ohms). Each sending unit seems to be a bit different, so, your reading will probably vary and the fuel gauge may not read accurately. The gauge can be calibrated to match the sending unit, but this is best left to a shop that specializes in that adjustment. Ira had already put a new sending unit into the tank with the supplied screws and a new viton gasket. He had used the recommended hylomar sealer, but I found it to be too slick and the gasket was squeezing out, so, I removed the sending unit and cleaned off the sealer and reinstalled the gasket without any sealer. I have found that sealer is usually not necessary. We did use a blue thread locker to seal the threads as these can weep fuel when worn. Moss Motors recommends a small nylon washer under each screw head, but the thread locker seemed to work fine.

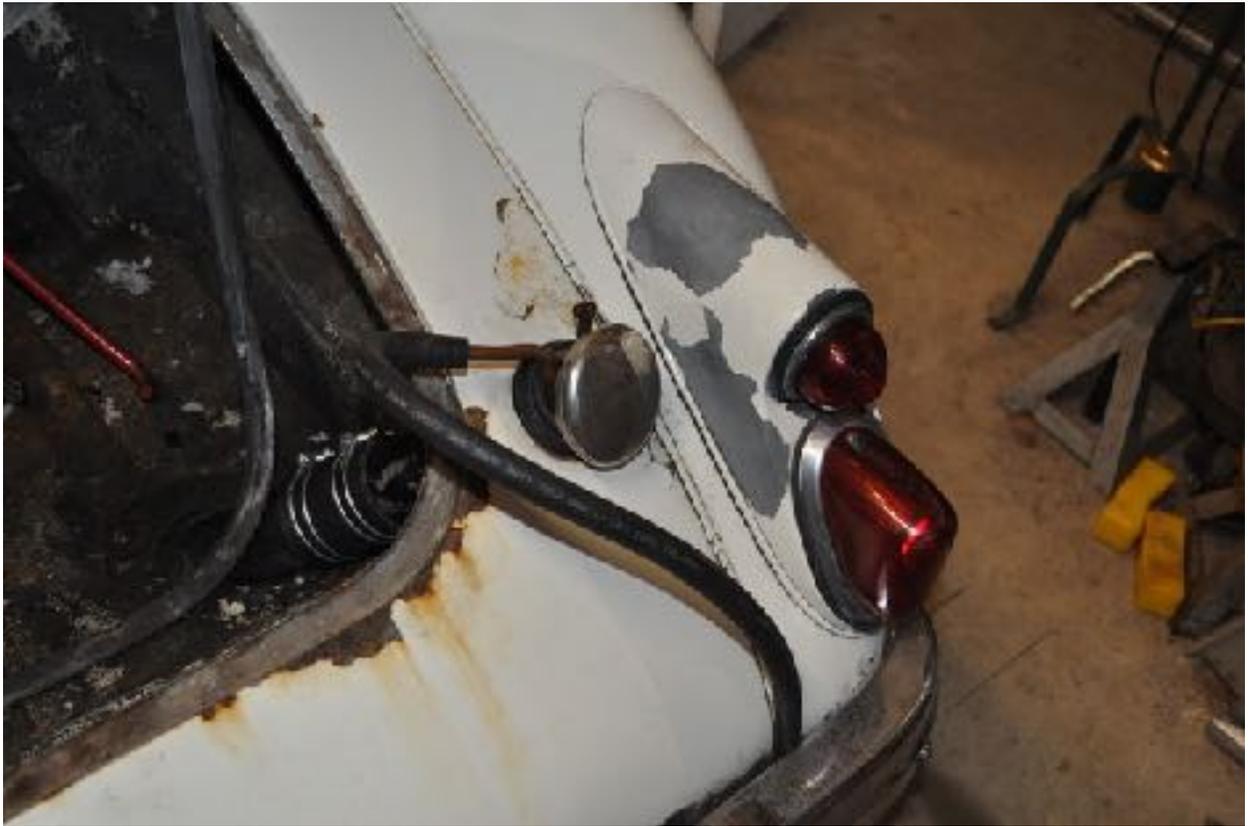
The temporary fuel feed fix

After completing the installation (in reverse order of the removal) Ira decided to take it to the end of my street to fill the tank the rest of the way. About 20 minutes later he came walking back and said the engine had died just before the gas station. We took the truck and towed the car back to investigate. I removed the fuel line from the rear carburetor and turned on the key and heard the pump working but no fuel came out (and the pump was clattering like it had no fuel). So, We put the car on the lift again, removed the right rear wheel and disconnected the fuel outlet line again. I put compressed air into the fuel outlet with the fuel filler cap open and we could hear the air, but no bubbles! We determined that the fuel pick-up line was not attached to the fuel outlet fitting. The fuel tank was not made correctly! Ira will have to see if he can contact the person he bought it from 10 years ago and see what can be done. In the mean time, We cut a copper pipe to feed into the filler tube and into the tank and attached a flexible fuel line from that to the fuel feed pipe to the fuel pump and the car was able to remain running and get fuel. We put a plastic bag over the fuel filler and feed pipe in order to keep rain out on the ride home.
