Adventures in replacing the Second Gear Synchro

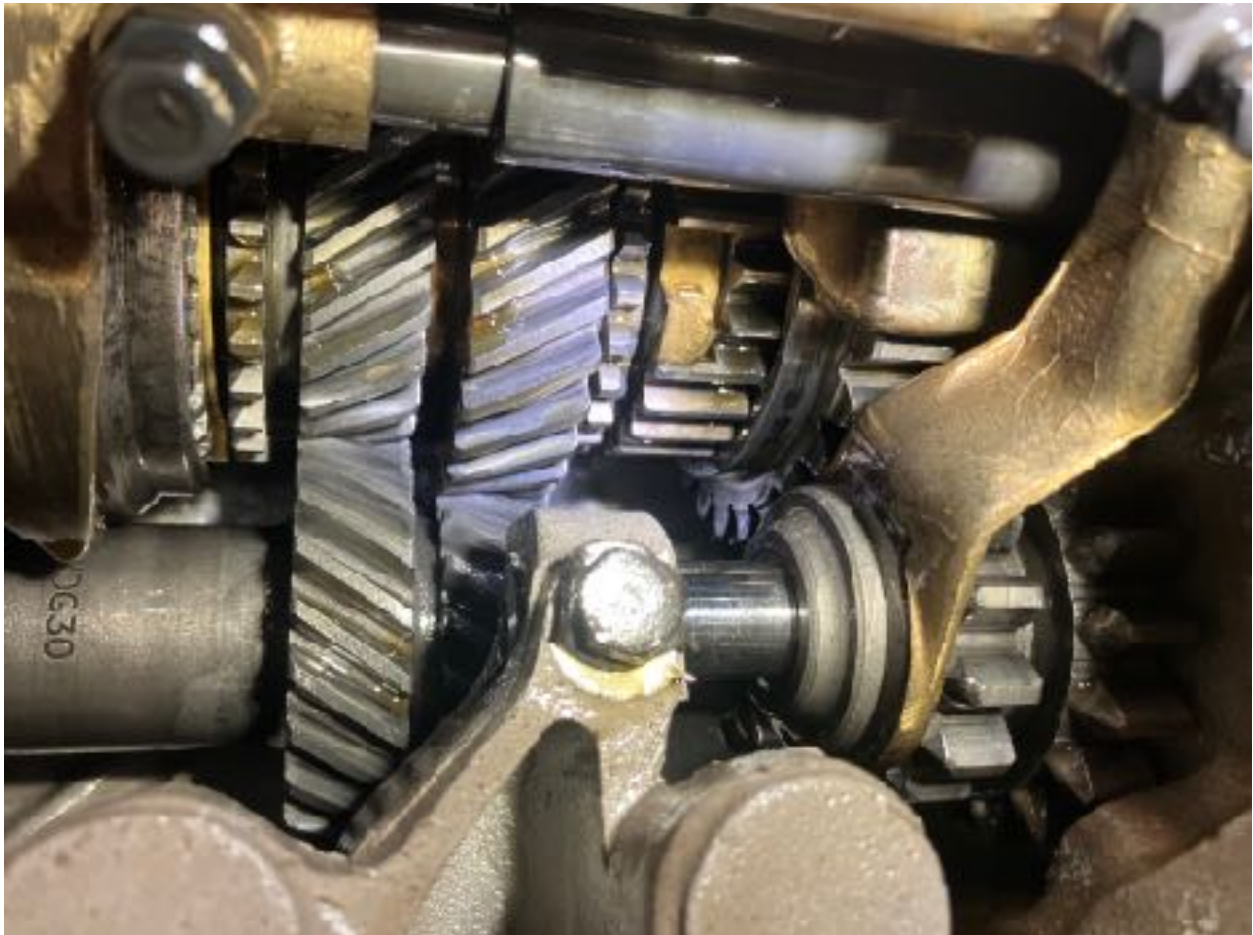
For the past couple years it has become more and more difficult to shift in and out of second gear on my 1960 MGA Roadster. Don Tremblay drove it last year for a test drive and I warned him he had to be “gentle” with the second gear and he definitely saw something amiss as well. I had been intending to get to my project for some time but my lift has been tied up for a couple years with friend’s projects. In the mean time I pulled out a spare gearbox and parts and along with some new parts built another “hybrid” gearbox. Since my MGA has a 5 main MGB engine, when I built the car in the late 1990s I had built a MGB gearbox (front housing) with an MGA tail section to make it easier to mate up to the engine. This entailed a engine rear backing plate from a 1965-1967 MGB, the front transmission housing and third motion shaft and the first motion shaft (output shaft and input shaft) from the same years MGB, MGB clutch throw out bearing, throw out fork and clutch. This particular transmission had the old style brass second gear synchro which tends to wear over time. When new the alignment sections look like a little peaked roof house, but as it wears it begins to look more like a steeple. See the picture below and you will see what it looked like when I looked at it.

Worn second gear synchro

So, I put together the replacement hybrid gearbox with one major improvement. About 1967 BMC started using a steel second gear synchro which lasts a lot longer (all MGB 4 synchro

gearboxes starting in 1968 have steel synchros in all forward gears). I put in the corresponding second gear (different from those that use a brass synchro ring) and new layshaft and all new seals. I also used a good set of selectors (these are often rounded and worn which can allow the selector lever to slip between two selectors and jam the transmission in two gears at once). I made sure that all my gear teeth were in good conditions selecting the best used parts I had. Now, with the transmission read to go it was time to get the MGA on the lift.

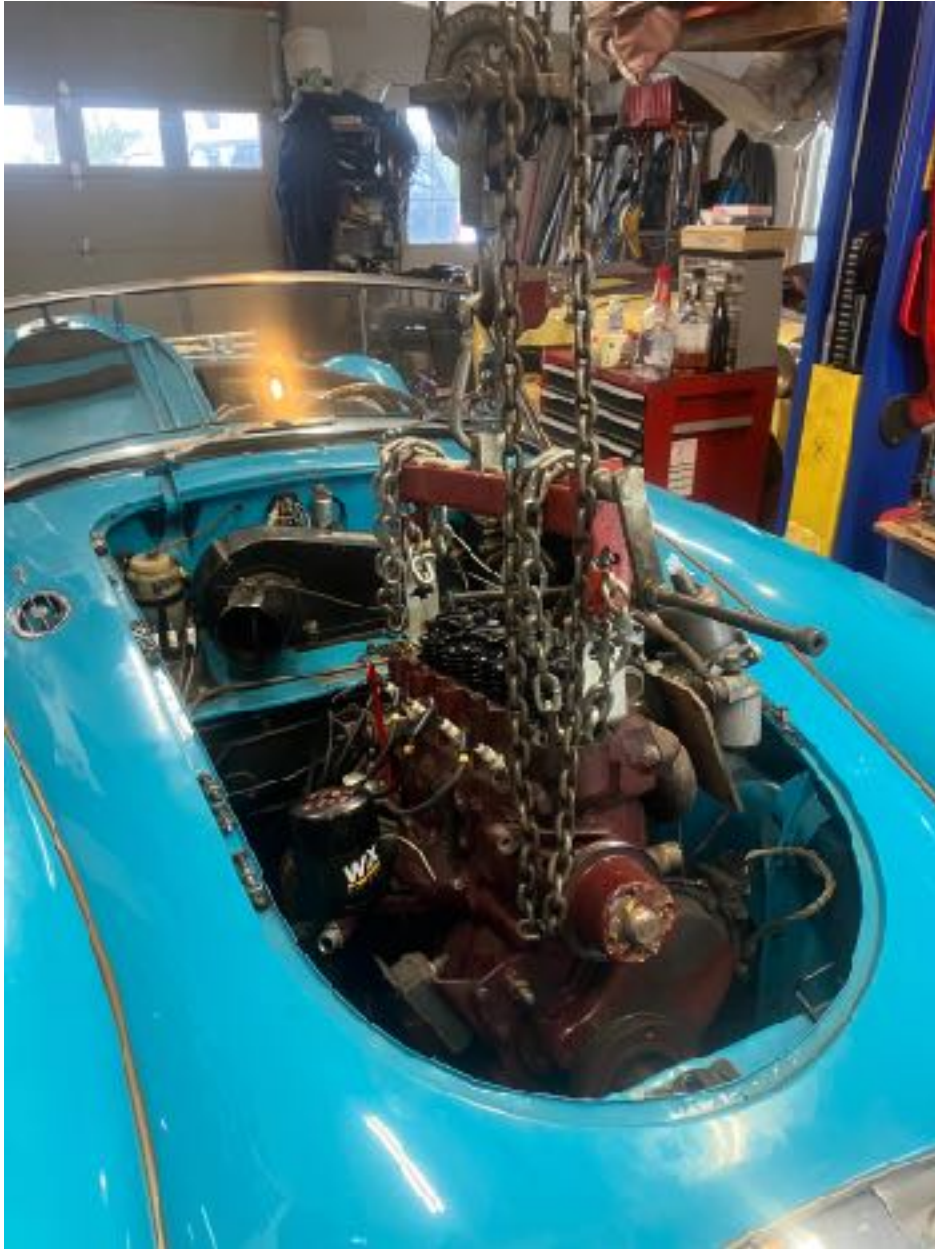
When pulling the engine and transmission together it does not require removing so many things off the engine. I removed the generator, carb air filters, and the exhaust down pipe and all the coolant pipes as well as the radiator but was able to leave the starter and carbs on the engine. While disconnecting the drive line and found a worn U joint, so, I went ahead and replaced that while the drive line was out (normally I'd leave it connected to the differential). The shift tower has to be removed also for the transmission to come out.

Engine and transmission coming out together

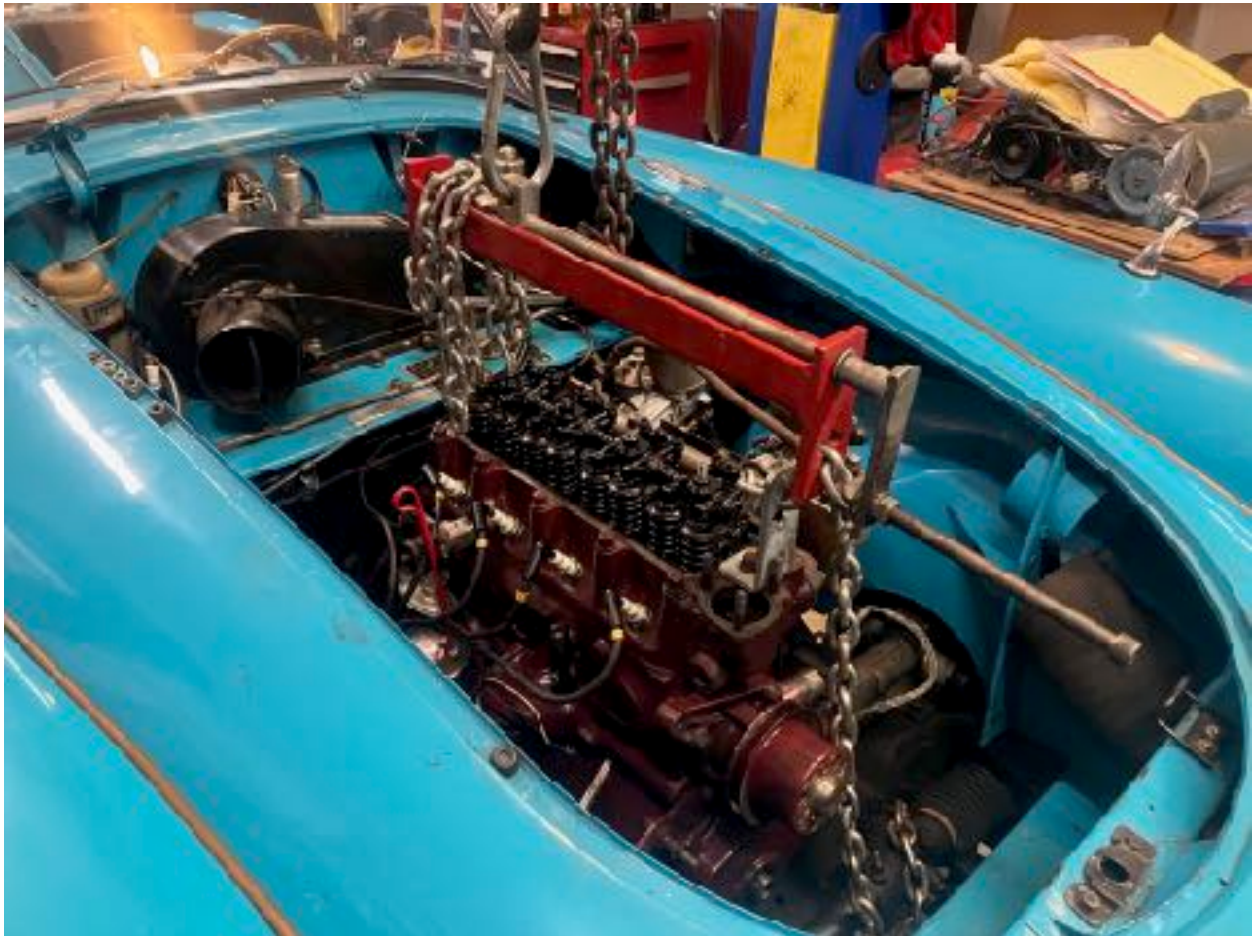
The next step was to drop the engine and transmission back into the engine bay. It has to be titled and just the right angle to clear. I removed the front damper pulley to allow just a bit more clearance at the front. As the engine drops in and the tail of the transmission slide into the transmission tunnel (guided by my helper) the angle of the unit has to be constantly changed to allow it to slip in without catching on the lip of the transmission tunnel. We got it almost all the way but it did not want to go that last 1/2" until I noticed that my chain from the lift was dangling down and fouling the transmission at the firewall! Once I pulled the chain out it dropped in the rest of the way. I did not replace the motor mounts as they were still like new, but this is the time to look for any and all serviceable items that should be addressed while accessible.

Engine and transmission back into engine bay

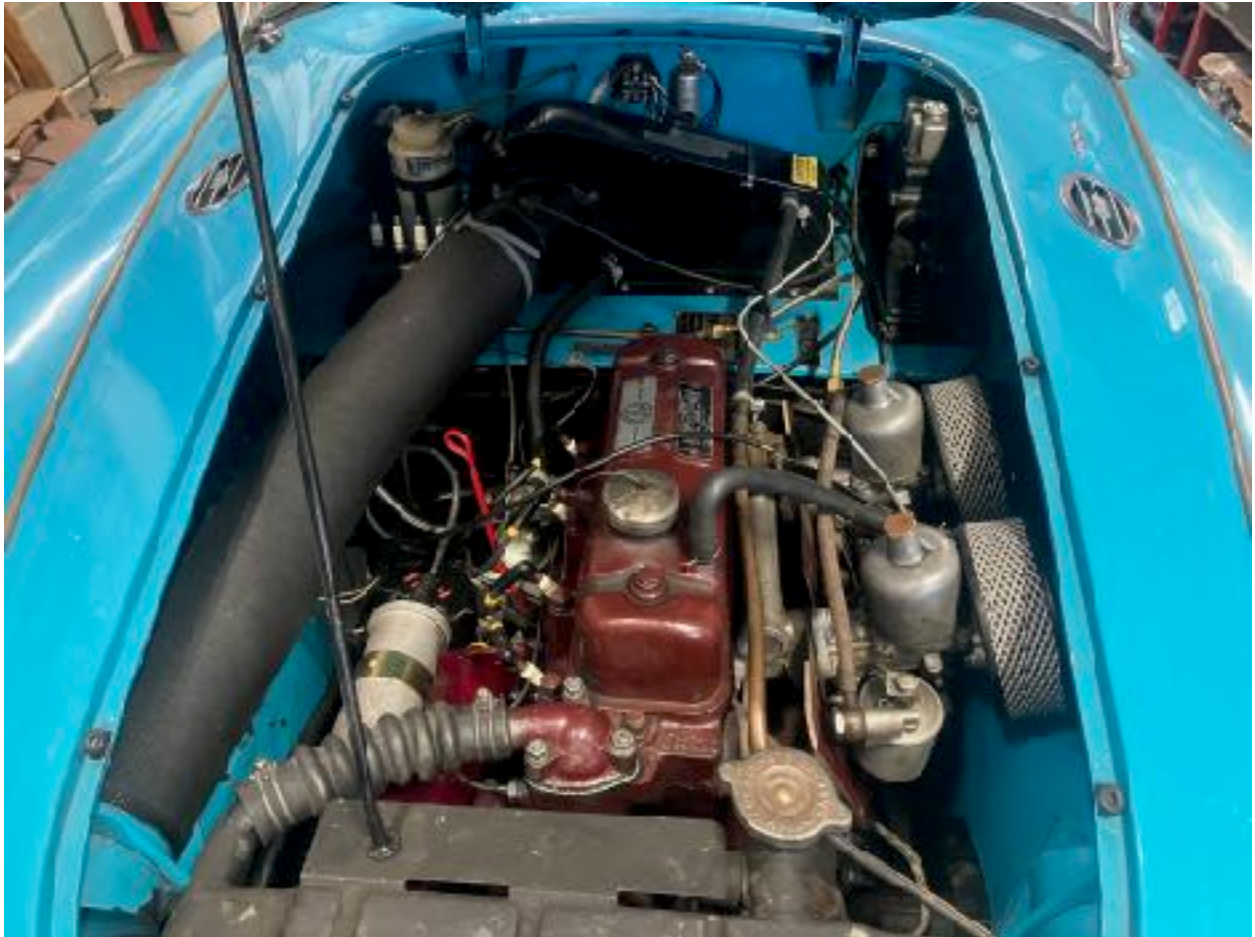
With the engine and transmission in position it was a straight forward procedure to reconnect and reinstall everything. Another thing I should mention is that the transmission cannot be filled until AFTER installation because of the tilt and without the shift tower not in place the oil would run out the opening in the tail section. I actually filled the transmission from the shift tower opening before installing it because it is a lot easier than filling at the dip stick!

And, here it is all back together
