What have you been doing in your quarantine?

Without talking about the “elephant in the room” I want to find out what others are doing with the self imposed “garage time”. Please write to me and let me know if you have tackled special projects during this past month or two. I have been tackling a 1974 MGB GT that has been off the road since 1992. A friend of mine purchased the car about 10 years ago and I helped him start it up about 5 years ago just to see how the engine ran. This involved turning the engine through by hand to make sure that there were no valves stuck in the closed position (this will cause the cam and crank to stop rotating or bend a push rod). This was not a problem. So, we cleaned the points and checked the gap, disconnected the fuel pump (as we did not know what condition the gas tank and fuel was in) and connected up a spare fuel tank and pump. We installed a battery to the normal connections and ensured a good ground connection at the battery. We made sure that the throttle dampers in the carburetors were free moving. We then turned on the ignition and cranked the engine. It cranked over well but did not want to start. I noticed that there was not much exha

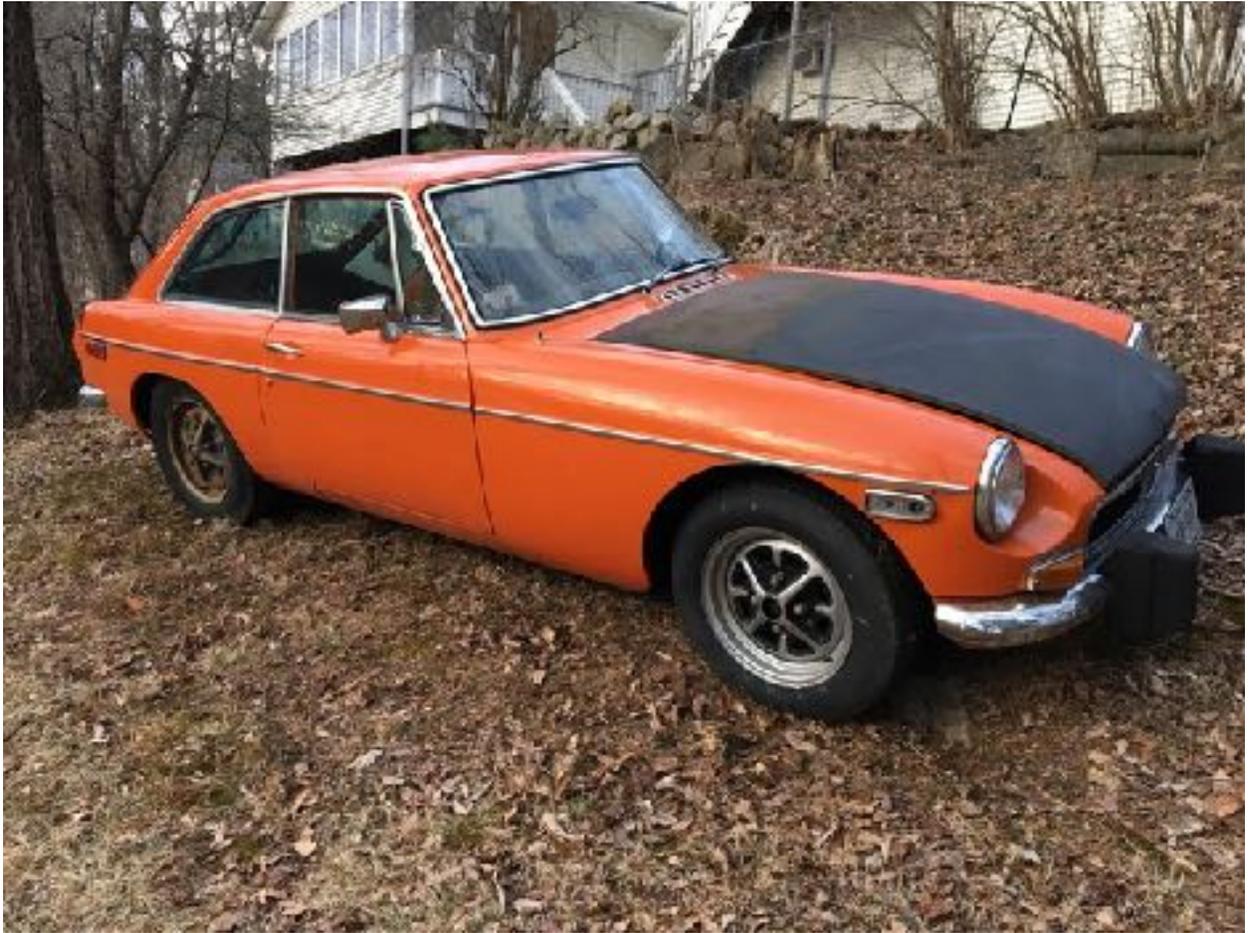
The 1974 MGB
