MG Wiring (Or, What I never expected to find in the rat's nest)

Safety Fast,
Jack Horner
President, Bay State MGA Club

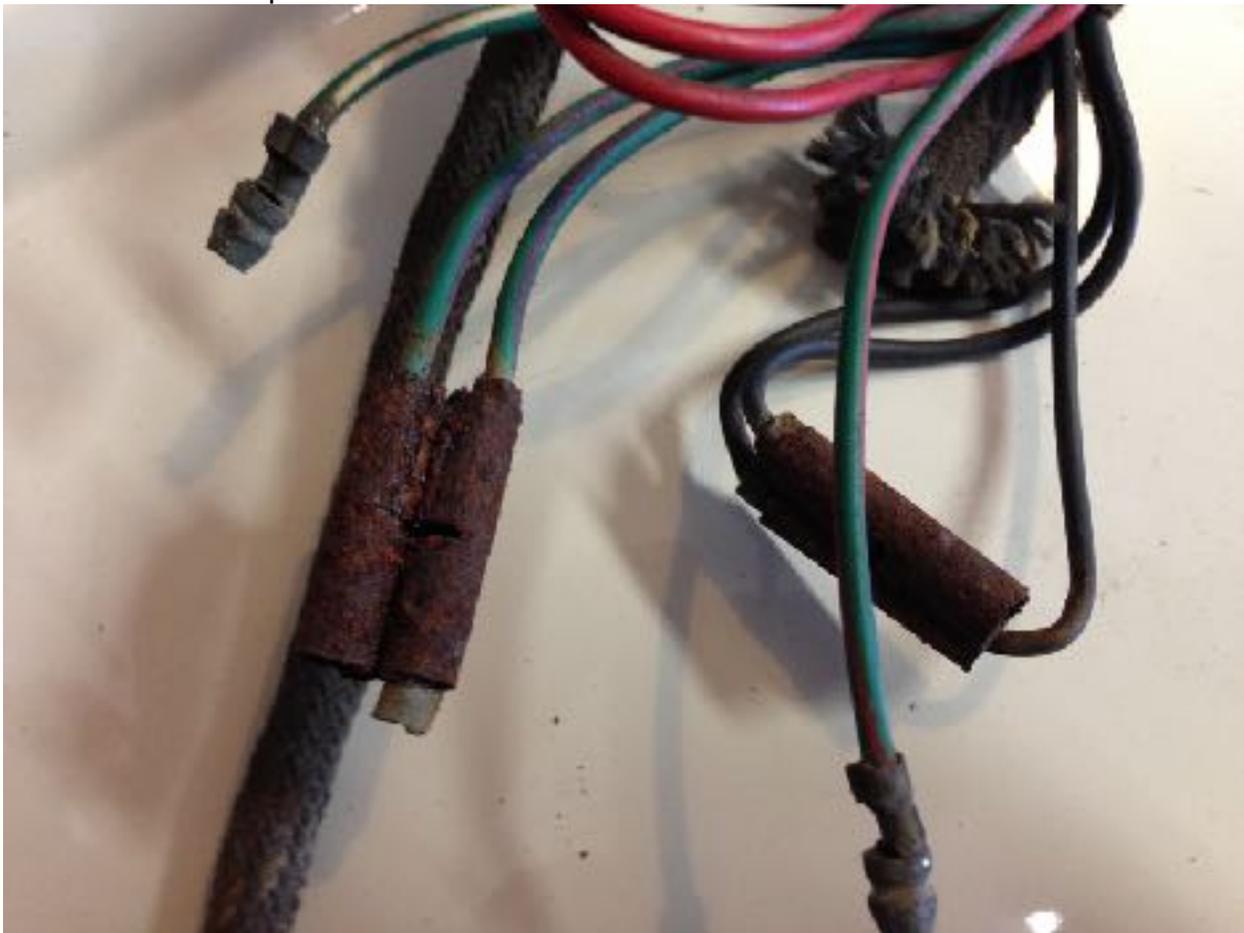
As you may recall, I finished putting Jan's MGA Coupe back together a couple years ago. One of the items I did not replace was the wiring harness as it already had a replacement wiring loom that had been installed in the late '70s or early '80s. It appears to be in good condition, but when I removed it I discovered that the replacement "snap" connectors (this is what Lucas calls the rubber covered female connector for wires with bullets crimped onto the ends) were made of steel (instead of the original nickel plated brass) and that those exposed to the elements were badly corroded.

MGA corroded snap connectors

While buying bullet ends and additional snap connectors I discovered that I could not find original type connectors. They were all made of steel; so, I cleaned up salvaged snap connectors to use on the coupe as I prefer them not rusting. Another thing I do for these connectors that are exposed to weather is squeeze some Ox-Gard (available at most hardware stores in the electrical department). It is an anti-oxidant compound that promotes conductivity. It is only used where wires are common to a single circuit. Where there are multiple conductors such as in light bulb bases I use a Non-conducting dielectric grease.

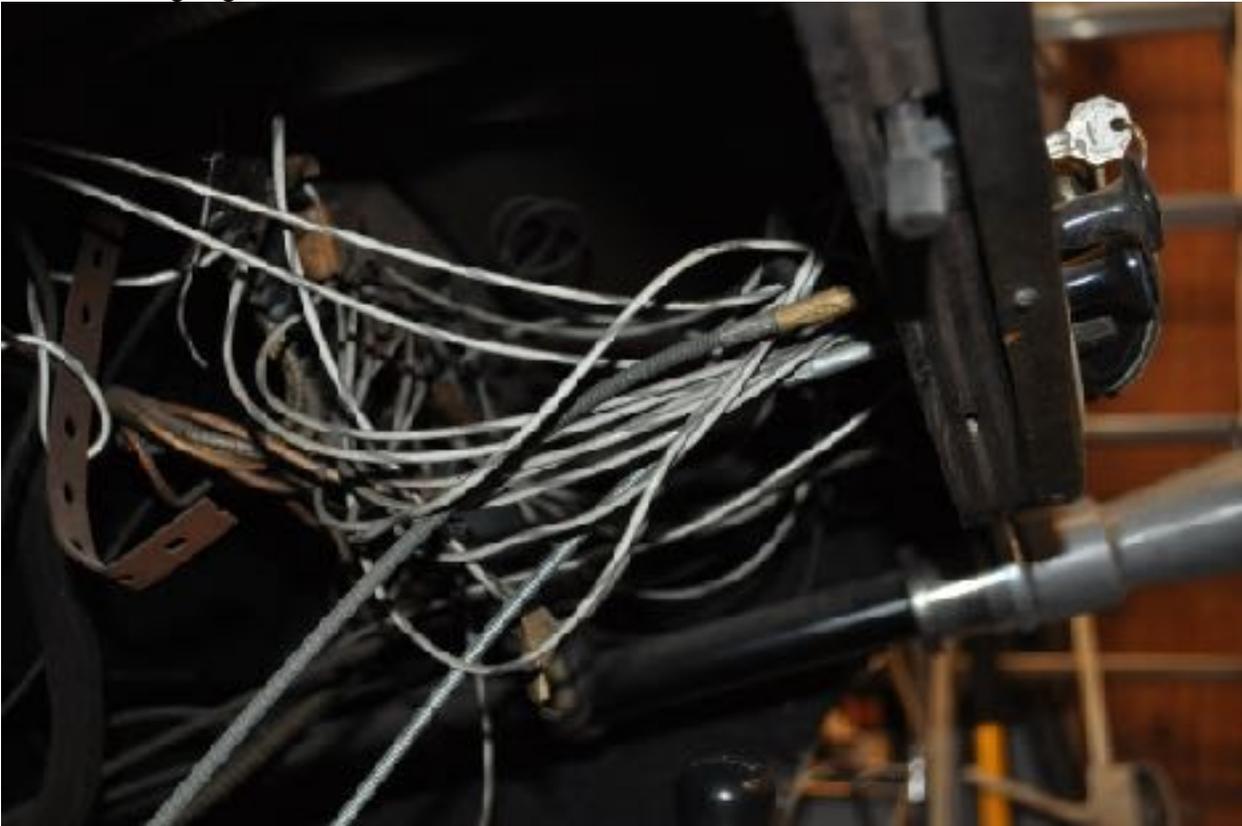
(which my TC did not come with). I have included a picture of what the previous owner was going with the wiring under the dash. All the wires were of the same color with masking tape label (numbers) which I have no clue as to what his numbering system was. He had installed a junction block with wire loop connectors to screw into the block to join the dash harness to the rest of the wiring. He had also done his own wiring for the headlights and driving lights. I have replaced all that with the new harness and will see if all the connections work once I get to that point. I did add relays for the headlights under the dash as well as a MGA style turn signal switch and the MGA 1500 style relay and flasher. I will let you know how it goes when the time comes. I still have to buy a battery for the car but I don't have the headlights and tail lights installed yet.

MGTC wiring nightmare

My current project is a 1948 MG TC. I am doing a complete rebuild. I was able to buy a nice wiring harness through Abingdon Spares for a good price and it includes wires for turn signals
